| 場所 | 国立大学通り | 樹木医名 | | 診断日 | 2024年3月18日 |

# 根株診断カルテ(レジストグラフ)

| 路線名 | 国立大学通り | 樹木医名 | | 診断日 | 2026年1月30日 |

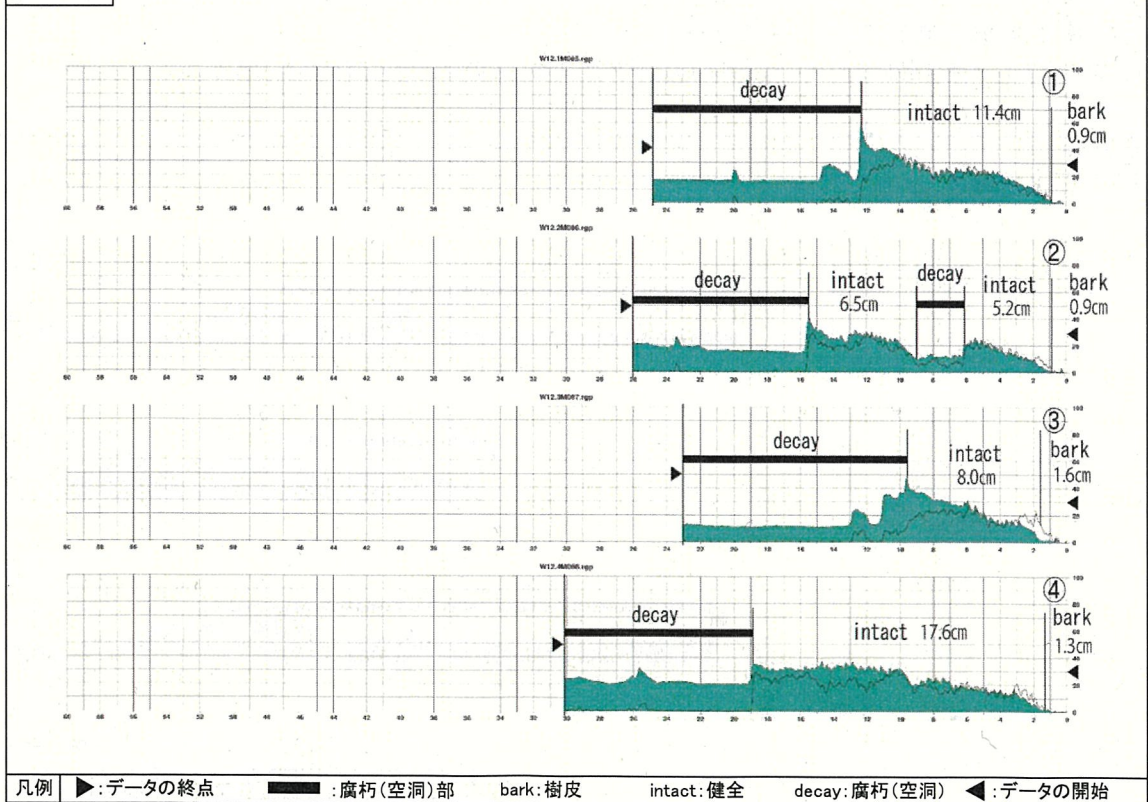
## 測定結果

心材に非常に大きな腐朽空洞がみとめられる。

①②③方向の健全材の厚みが薄くなっている。

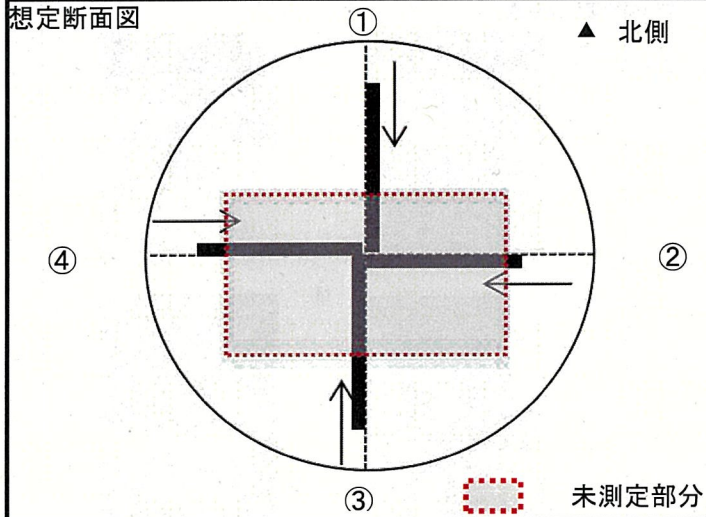
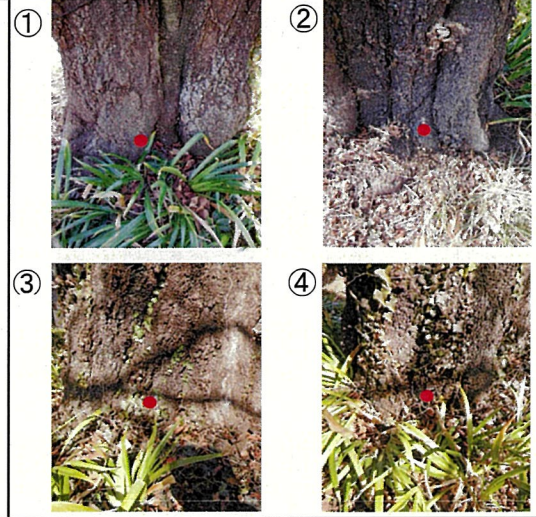
腐朽空洞率は64.1%、C判定、不健全なものであった。  
根株心材に非常に大きな空洞部が見られ、倒木の危険性が認めらるので安全対策が必要である。

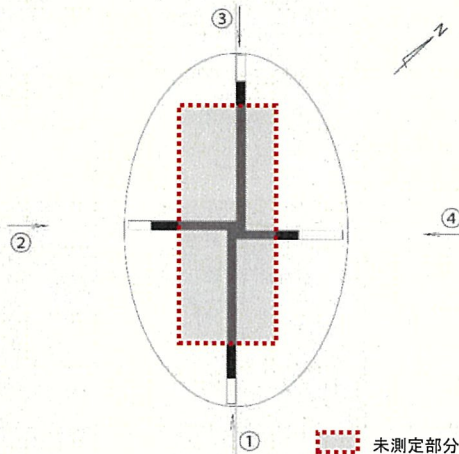
想定断面図

所見  
 心材に非常に大きな腐朽空洞がみとめられる。  
 ①②③方向の健全材の厚みが薄くなっている。

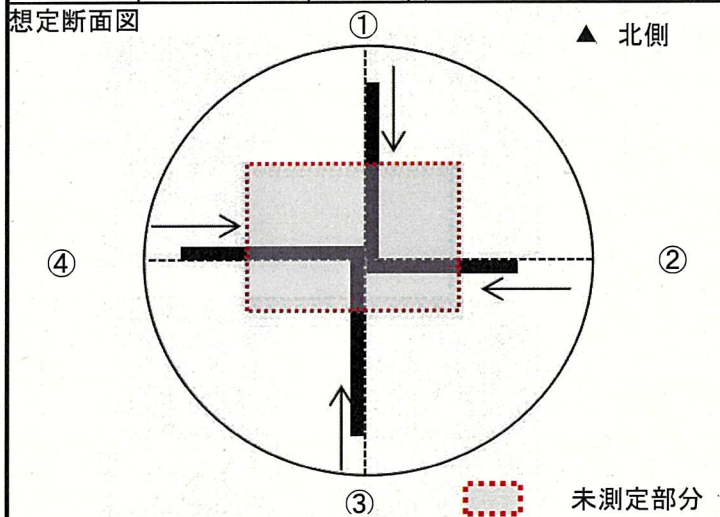
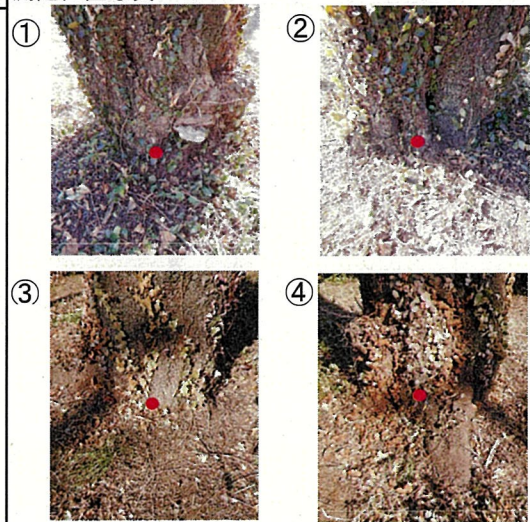
腐朽空洞率は63.6%、C判定、不健全なものであった。  
根株心材に非常に大きな空洞部が見られ、倒木の危険性が認めらるので安全対策が必要である。

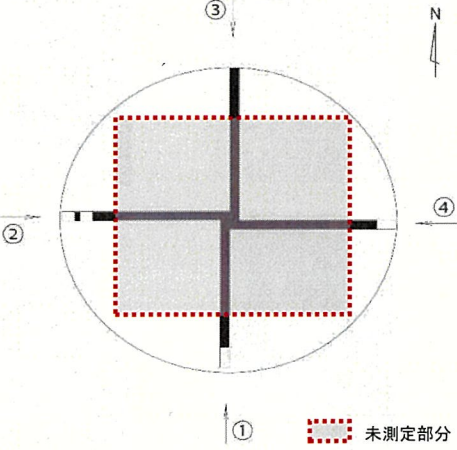
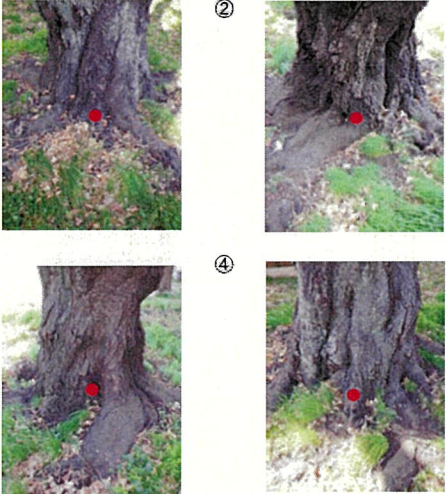
所見  
 辺材から心材に極めて大きな腐朽空洞がみとめられる。  
 ③方向は辺材から心材にかけて健全材がほぼない。①②④方向の健全材の厚みが薄くなっている。  
 現状で倒木の危険性あり。
